LAMPIRAN

Lampiran 3 Hasil Pengujian Ketebalan Menggunakan *Ultrasonic Testing*

Lampiran 4 Hasil Pengujian Penetrant Testing

Lampiran 6 Foto Inspeksi RFCCU

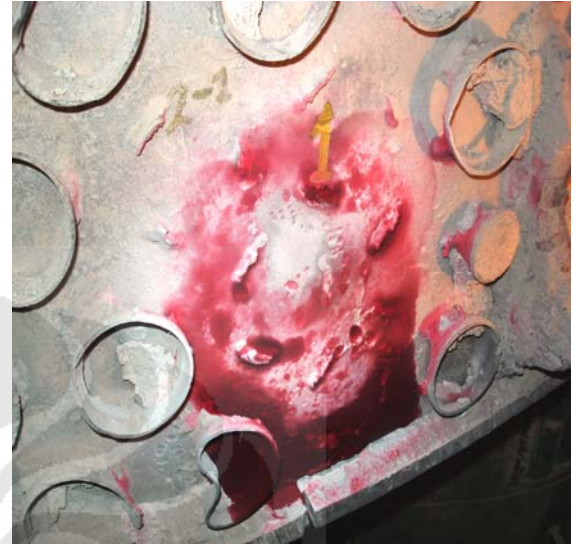
Penetrant Test dilakukan setelah Replika pada lokasi titik No.1 (72°/A) pada shell plenum material lama.

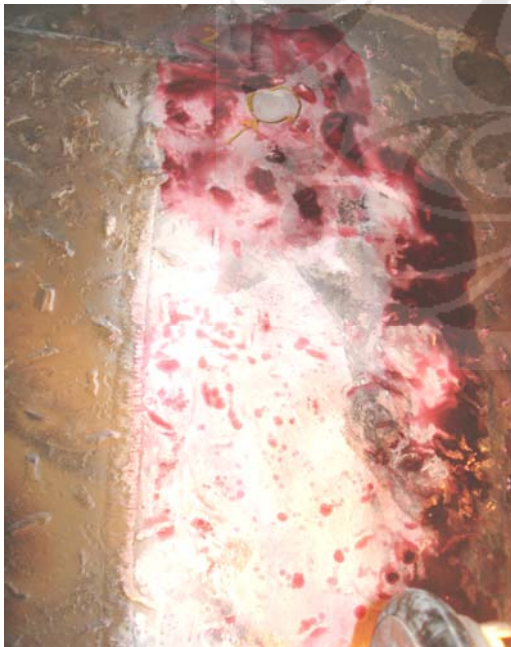
Nr.	Part Identification	Indication of Discontinuities		Judgment		Remark
		Type	Size (mm)	Repair	Accepted	
	TOP SHELL AREA:					
	lowerside of plenumshell (Outside);					See Sketch
1	Replica No.1 area (A / 72 °)	ND	-	-	√	
2	Replica No.2 area (E - A / 108 °)	Crack	12	√	-	
3	Replica No.3 area (E / 144 °)	ND	-	-	√	
4	Replica No.4 area (D / 216 °)	ND	-	-	√	
5	Replica No.5 area (D / 216 °)	ND	-	-	√	Patching plate
6	Replica No.6 area (D / 216 °)	ND	-	-	√	
7	Replica No.7 area (D / 216 °)	ND	-	-	√	Patching plate
8	Replica No.8 area (D / 216 °)	ND	-	-	√	
9	Replica No.9 area (D / 252 °)	ND	-	-	√	Patching plate
	Upperside of plenum shell (Inside);					
10	Replica No.10 area (C-D / 252 °)	ND	-	-	√	
11	Replica No.11 area (B-C / 324 °)	ND	-	-	√	
12	Replica No.12 area (A-B / 364 °)	ND	-	-	√

Titik No.2, ditemukan retak pada shell plenum lokasi (insert plate area) shell lama.

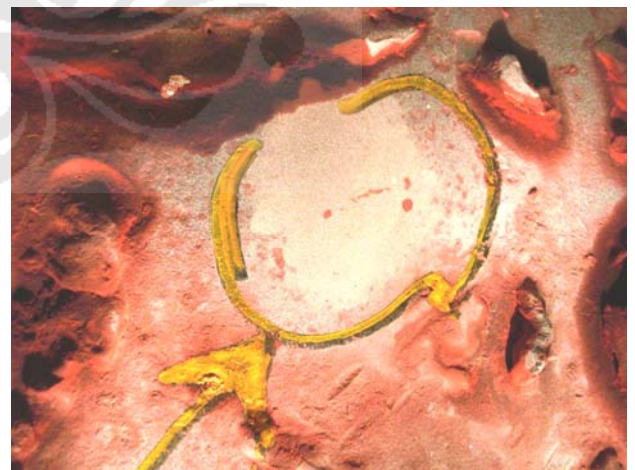
Panjang retak terlihat jelas setelah dilakukan Penetrant Test, pada titik No. 2 (108°/A-E).

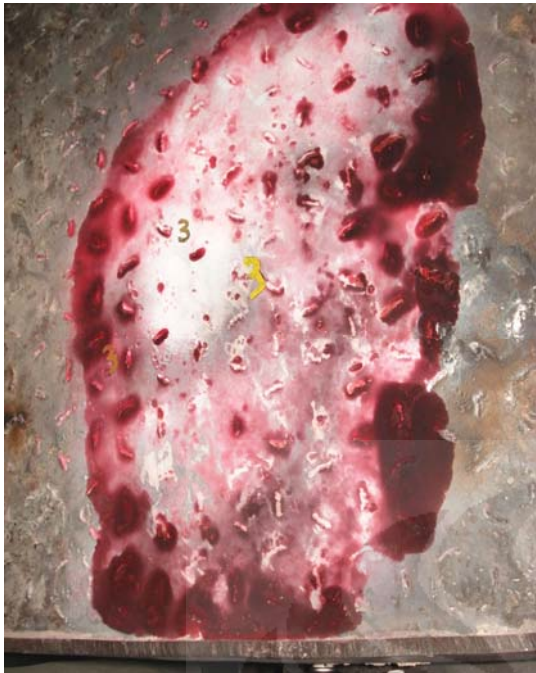
Titik No. 3 (144°/E) setelah dilakukan Penetrant Test pada lokasi shell plenum lama.

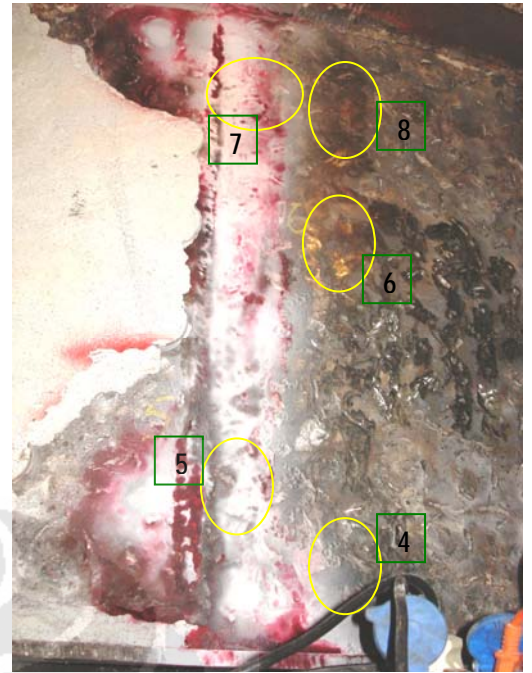
Titik No. 4, 5, 6, 7 & 8 (216°/D) setelah dilakukan Penetrant Test pada lokasi shell plenum lama & baru (No. 5 & No. 7).

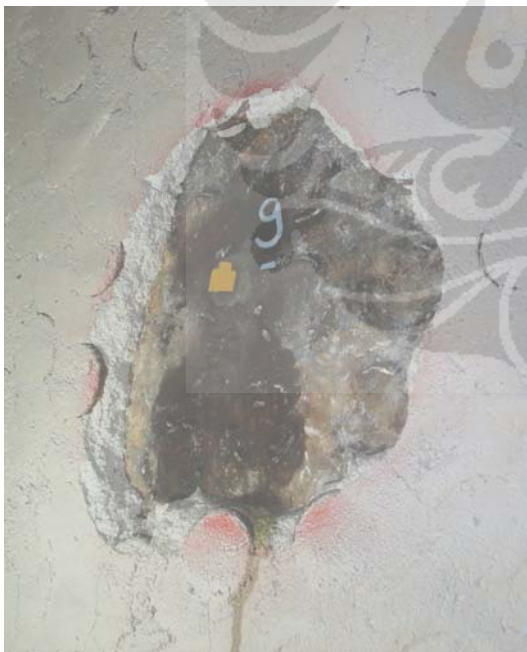
Titik No. 9 (252°/C-D) setelah dilakukan Penetrant Test pada lokasi shell plenum baru.

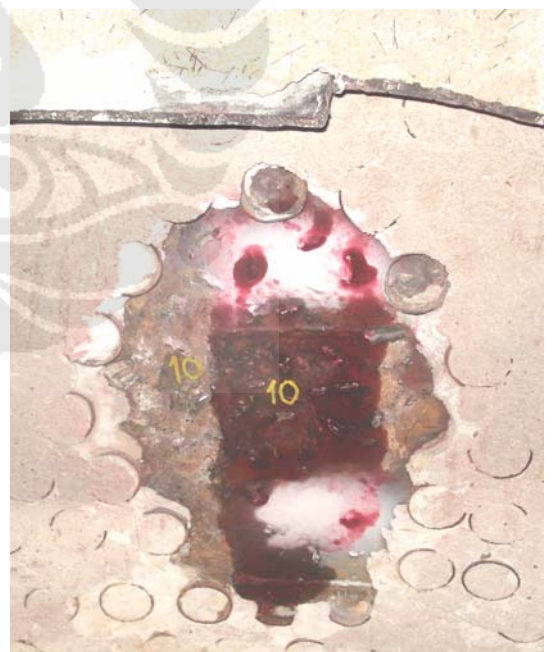
Titik No. 10 (252°/C-D) setelah dilakukan Penetrant Test pada lokasi shell plenum lama bagian atas header.

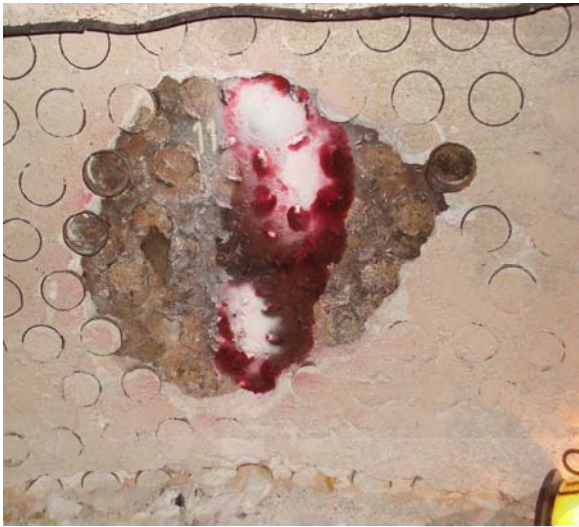
Titik No. 11 ($324^\circ/\text{B-C}$) setelah dilakukan Penetrant Test pada lokasi shell plenum lama bagian atas header.

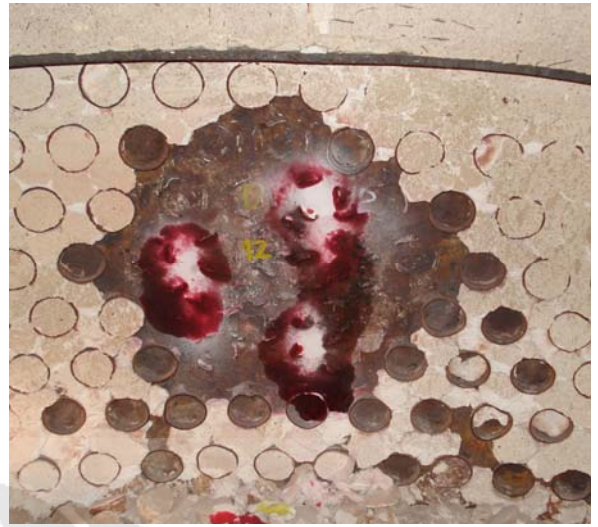
Titik No. 12 ($36^\circ/\text{A-B}$) setelah dilakukan Penetrant Test pada lokasi shell plenum lama bagian atas header.

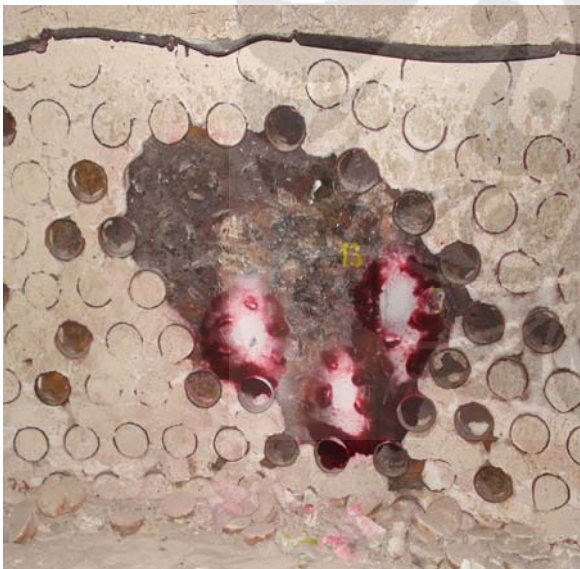
Titik No. 13 ($108^\circ/\text{E-A}$) setelah dilakukan Penetrant Test pada lokasi shell plenum lama bagian atas header.

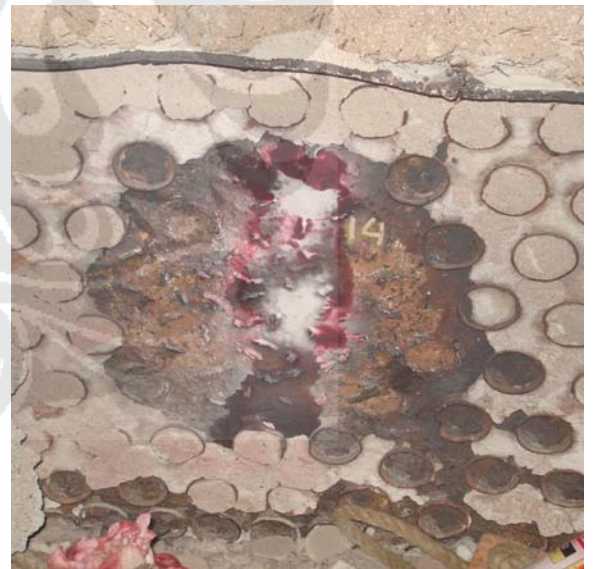
Titik No. 14 ($180^\circ/\text{D-E}$) setelah dilakukan Penetrant Test pada lokasi shell plenum lama bagian atas header.
