Surface Structure Study of Crystal Hydroxy-Apatite from Fluorosis Enamel

Abdillah Imron Nasution* Harun Asyiq Gunawan** Sri Angky Soekanto**

*Dentistry Study Program, Faculty of Medical, Syiah Kuala University,

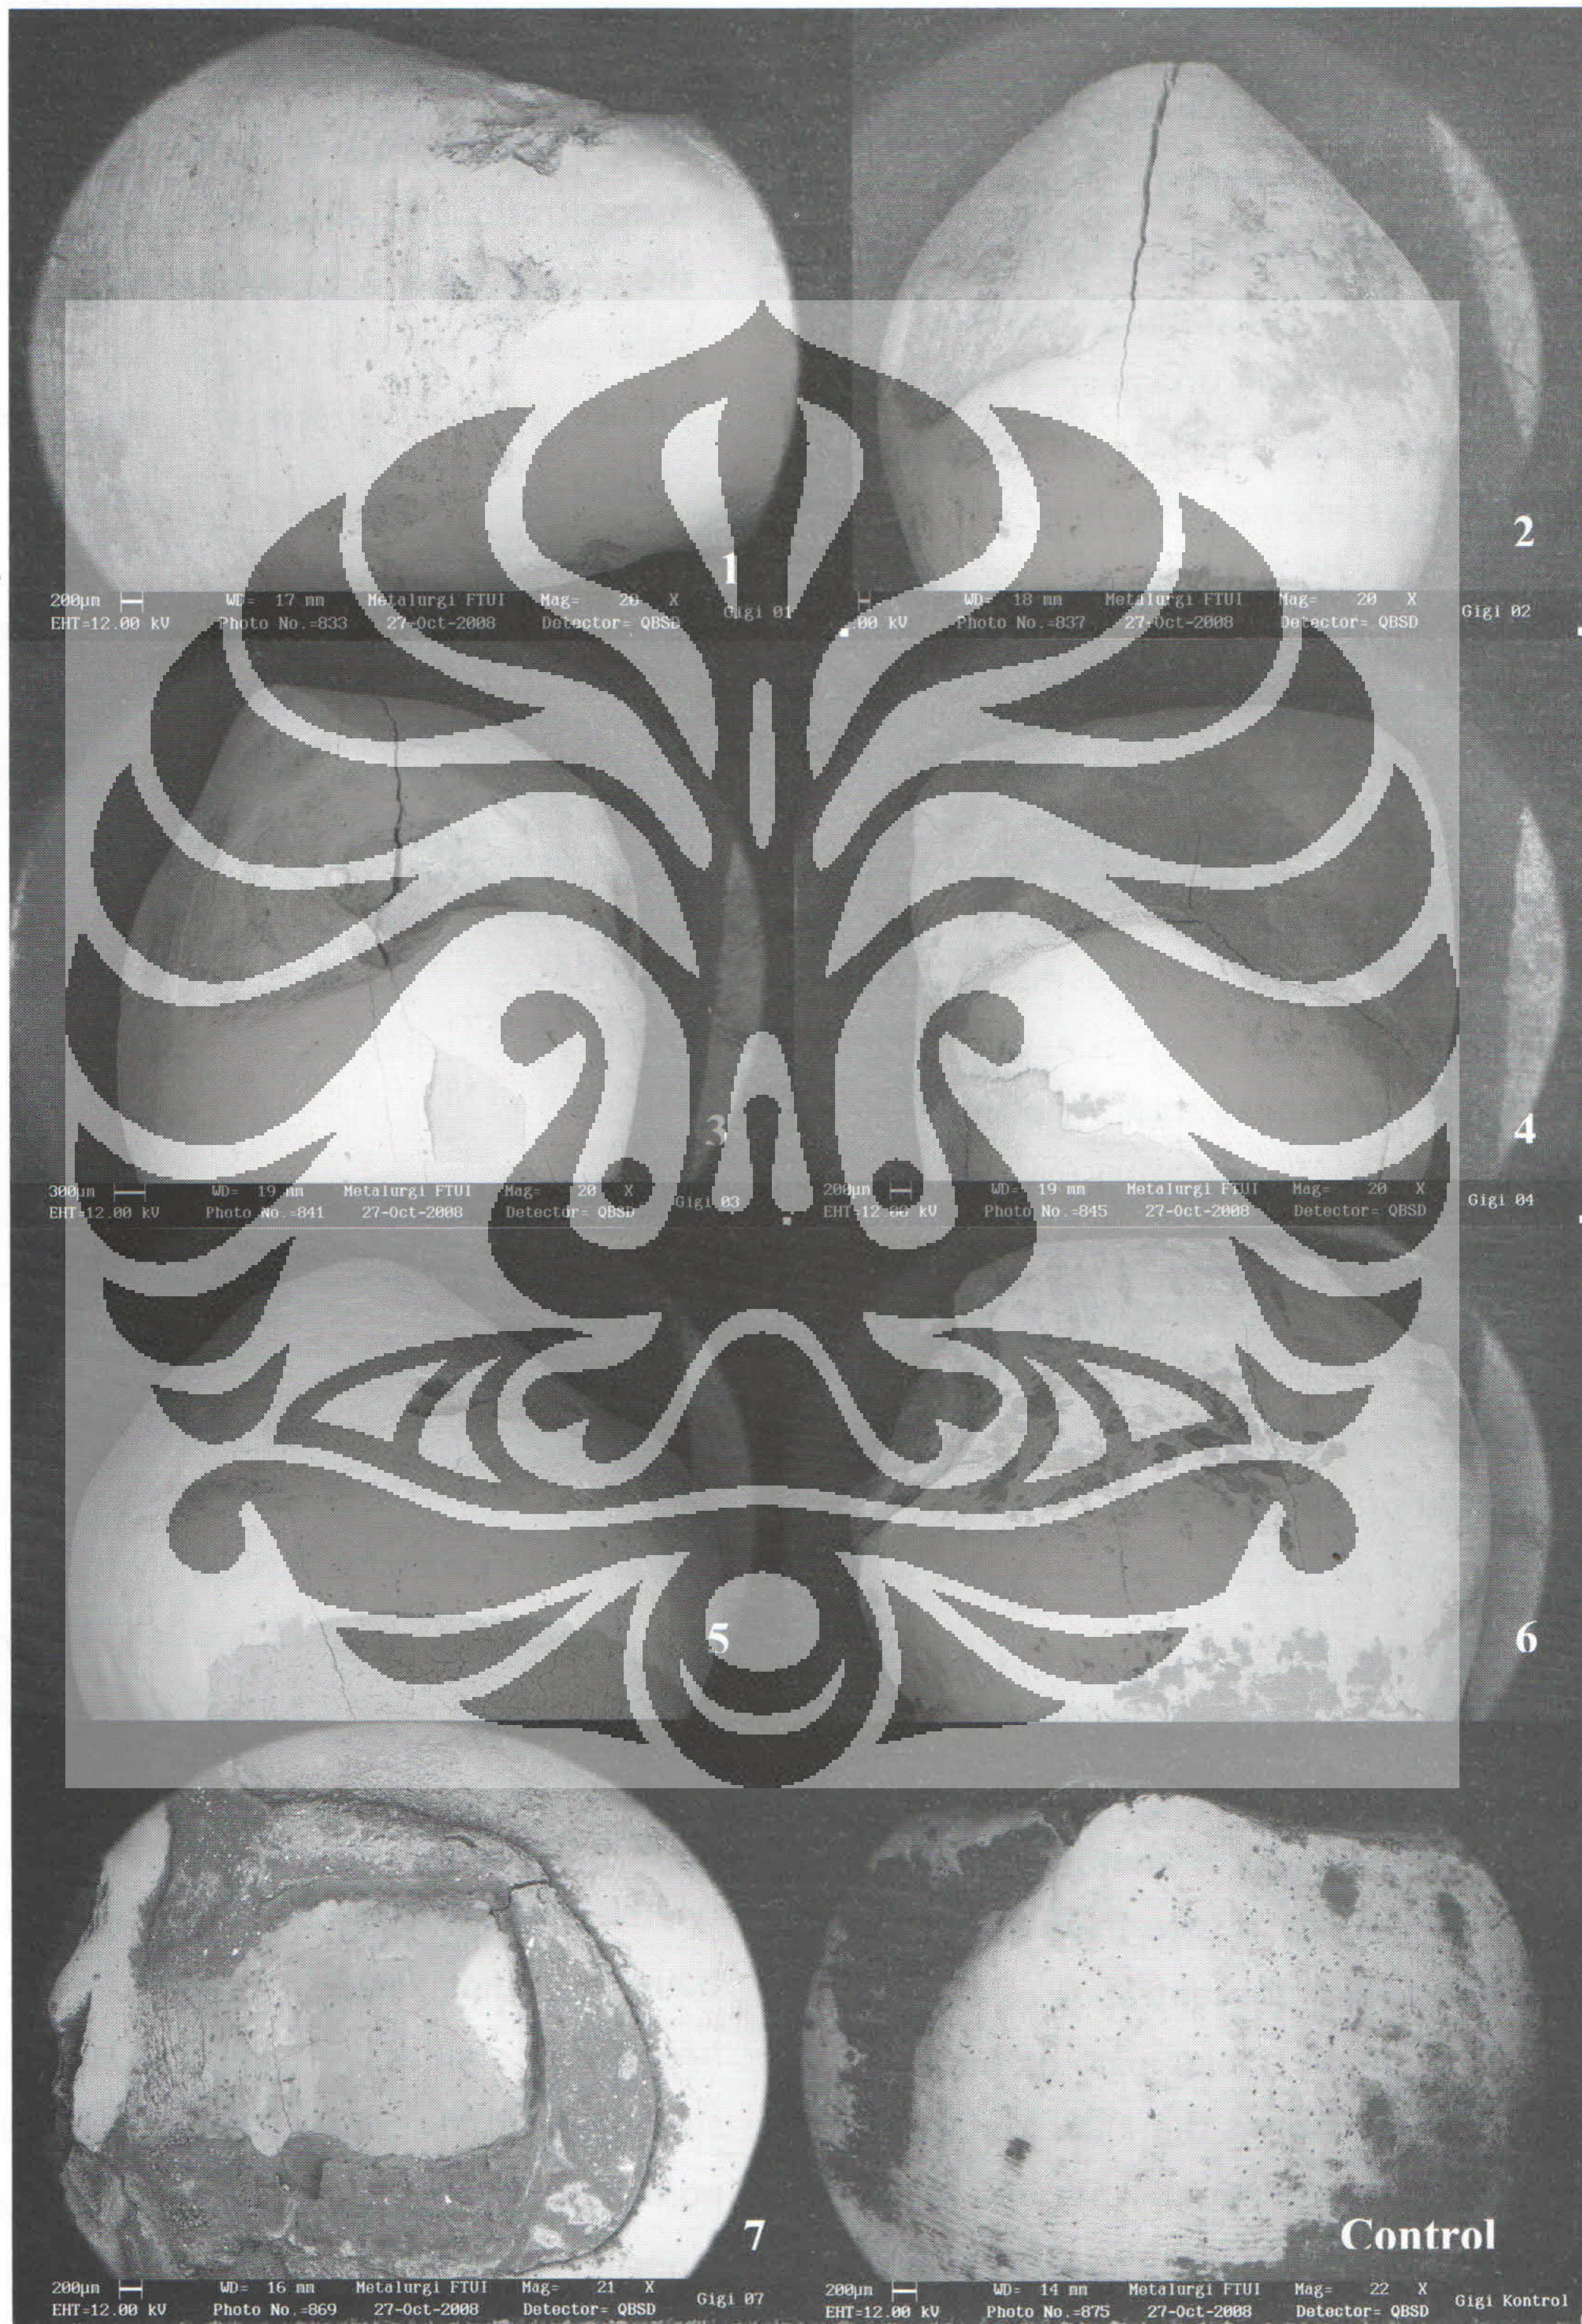
Fig. 1. SEM of all specimens (Magnification 20X)

Clinical characteristic appearance of specimen 05 showed loss of the occlusal part with small white spot hypoplastic areas appearance on enamel formation and displayed a brownish snowcap on the surface. Clinical appearances of specimen 06, showed the opaque lines which generated small cloudy areas that scattered on the surface. The specimen also showed surrounding pits with major part of the outer enamel has changed the tooth anatomical shape. Enamel surface shown an opacity and opaque enamel. This condition revealed white to dark-gray striations in part of the enamel. Specimen 07 showed loss of the outer enamel which resulted a change in anatomical shape of the surface with brownish and rough area. General aspect and clinical appearance were carried out by SEM shown on Figure 1.

Crown surfaces of all fluorosis specimens demonstrated surface damage, ranging from scattered small pits to partial loss of the outermost enamel. Most of these areas acquired dark-grey pigmentation. These conditions were especially shown on specimen 03, 04, and 07 which shown the enamel was

loss on the mesio-incisal area. Crack and fissure were also displayed on the surface particularly in specimen 03 and 04. Crack and fissure conditions, made tooth become two irregular sections. In addition, some areas demonstrating no surface damage appeared cloudy to opaque and had entirely lost the normal translucency of intact enamel. The area beneath the thin surface layer generally was opaque when observed by magnification of 20X by SEM.

Specimen 04 showed fluor concentration of 22.20% with loss of enamel surface which changes the tooth shape. In specimen 03, the fluor concentration was

15.3% with rough surface area and crack line that rises from the pit. Pits from occlusal were seen running across to the cervical and changed the enamel shape. The fluor concentration on specimen 07 is 9.83%. SEM showed rough and damage enamel surface. Fluor concentration on specimen 06 is 9.76%. SEM showed rough surface with pits formation and damage enamel. The fluor concentration on specimen 01 is 7.35%. SEM showed rough surface and pits formation which spread away both in occlusal and cervical areas. Specimen 02 showed fluor concentration of 4.8 %. Specimen 05 showed low fluor concentration level of 4.04 % and SEM picture did not show porous area on the entire enamel surface. Small part of rough enamel as shown on the surface, demonstrated higher fluor concentration than other areas in this specimen. Specimen control with the lowest fluor concentration value (0.23%) showed a solid substance, with small pores, as regular pattern. Sign (*) which found on fluor concentration mean no fluor concentration on the enamel surface.
