**PEMODELAN INTEGRITY MANAGEMENT SYSTEM
PADA JARINGAN PIPA TRANSMISI GAS ALAM
DI OFFSHORE NORTH WEST JAVA**

TESIS

**FAKULTAS TEKNIK
PROGRAM STUDI TEKNIK KIMIA
JAKARTA
DESEMBER 2008**

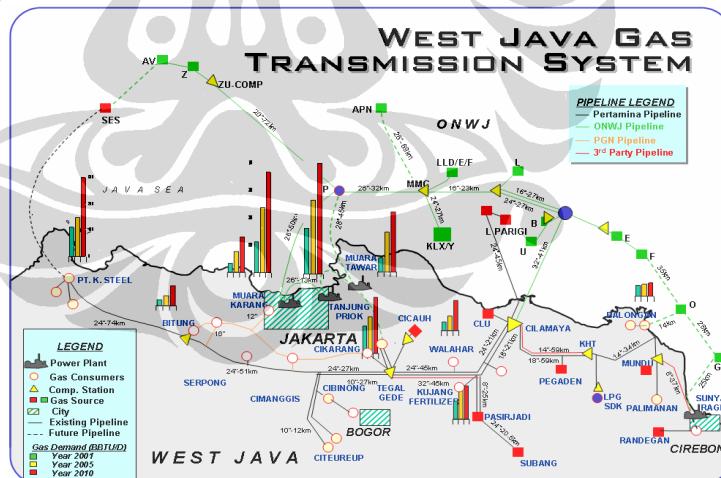
Gambar 2.4. Skema sistem west java transmissi.

Saat ini, total produksi minyak bumi dari BP West Java sebesar 26000 bopd yang dialirkan ke fasilitas penyimpanan terlebih dahulu sebelum dikirim melalui pengapalan, ada tiga titik yang digunakan sebagai penyalur produksi minyak bumi yaitu BP Arjduna, Zelta-CNOOC dan Pertamina Balongan (tidak aktif). Sedangkan untuk produksi gas bumi sebesar 270 mmscfd dipasarkan langsung melalui jaringan pipa transmisi bawah laut untuk mensuplai ke PLN Muarakarang, PLN Tanjung Priok, PGN dan Cilamaya (Pupuk Kujang). Suplai gas bumi untuk masing-masing klien tersebut jumlahnya adalah 55 mmscfd untuk PLN Muarakarang, 90 mmscfd untuk PLN Tanjung Priok, 70 mmscfd untuk PGN dan 50 mmscfd untuk Cilamaya [3].

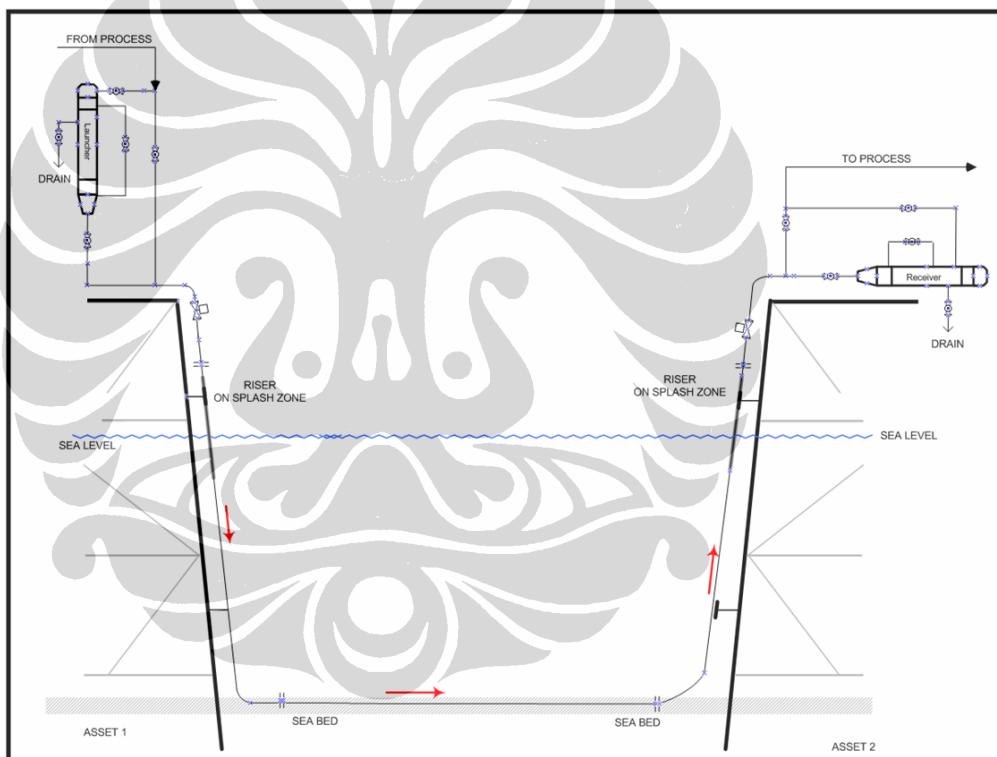
Gambar 2.5. Batasan jaringan pipa atau pipeline bawah laut.

Batasan *offshore pipeline* atau sistem jaringan pipa bawah laut yang dimaksud disini adalah semua komponen *pipeline* yang diletakkan di dasar laut/seabed yang berguna untuk mentransportasikan minyak bumi atau gas bumi, dimana didalamnya termasuk riser, valve dan pressure vessel (pig launcher/receiver) hingga mencapai valve yang merupakan isolasi pertama dari topside facilities [11].

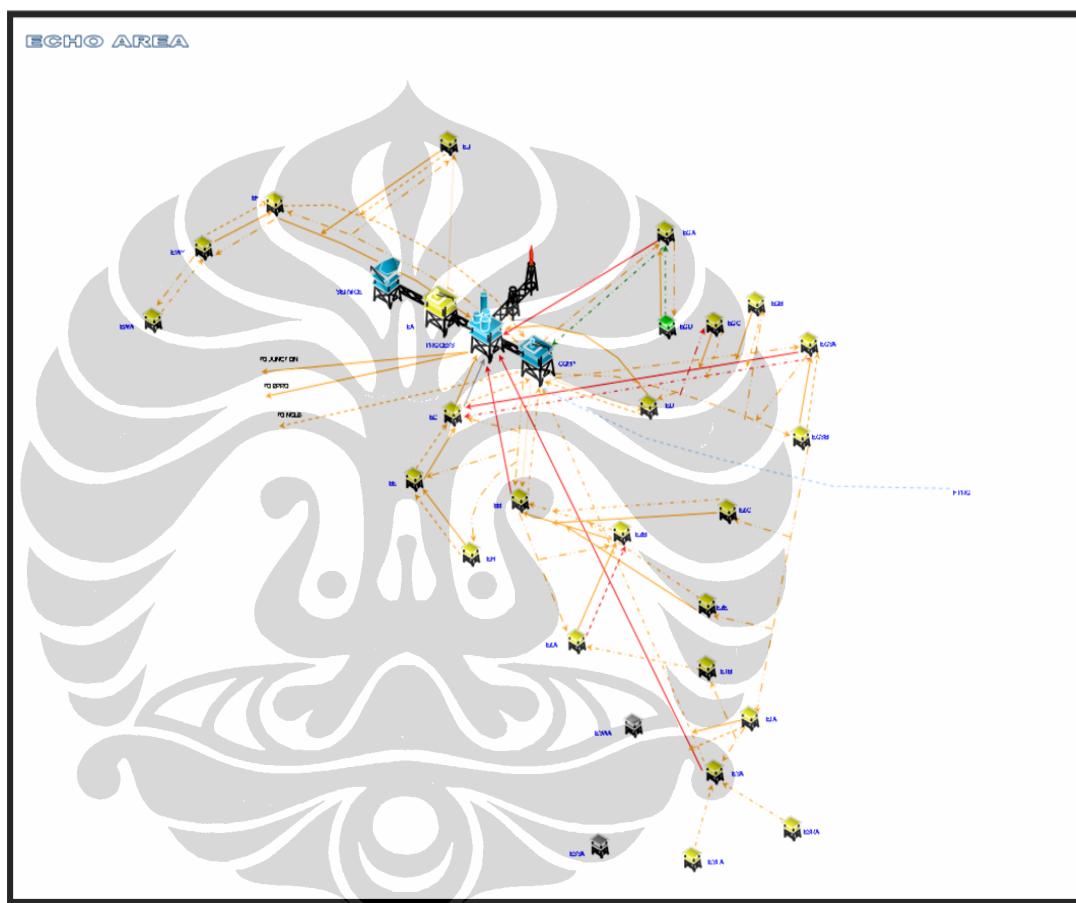
Gambar 2.6. Platform dan jaringan pipa bawah laut di Echo area - BP West Java.

berjumlah 102 dan pipeline yang mengalirkan water injection berjumlah 3 pipeline [14]. Dengan jumlah pipeline ratusan tersebut, maka BP West Java dituntut untuk melakukan strategi integrity manajemen terhadap jaringan pipa yang ada. Pada gambar 2.5. salah satu contoh area yang ada di BP West Java yaitu area Echo, sedangkan 10 area yang lain merupakan lapangan yang sejenis dengan tingkat kompleksitas yang berbeda.

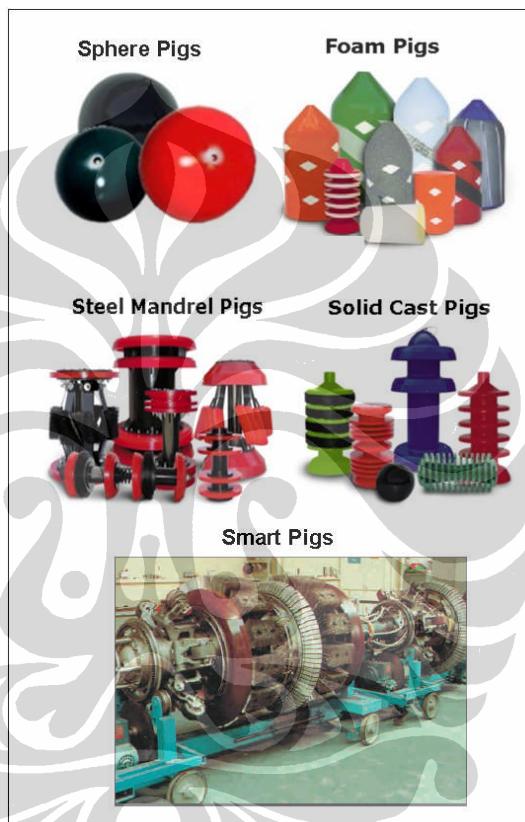
Gambar 2.7. Jenis-jenis pig

2. In-Line Inspection Tools/Smart Pig, yaitu jenis pig yang digunakan untuk melakukan inspeksi dinding pipeline dan mengidentifikasi defect yang ada pada pipeline, mengetahui geometri ukuran dari pipeline, dan mapping dari sub sea pipeline. Pig jenis ini digunakan tergantung pada data yang diinginkan oleh pemilik pipeline. Teknologi yang ada dan dapat digunakan saat ini adalah *Magnetic Flux Leakage (MFL)* dapat mengetahui metal loss external dan internal, dent, bends serta buckles, *Ultrasonic Technique (UT)* dapat mengetahui metal loss external dan internal, dent, bends, buckles, mill defect serta cracks, *Caliper* dapat mengetahui geometri dari pipleine, *Inertial Measurement Unit (IMU)* berisi odometer dan gyroscope yang berhubungan dengan Global Positioning System (GPS) untuk mengetahui lokasi.

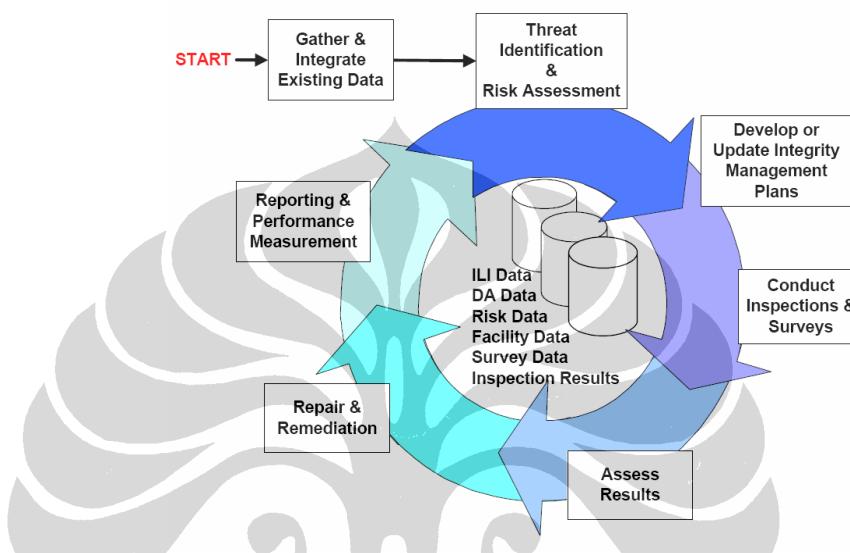
Gambar 2.8. Pipeline integrity management sistem

telah direncanakan, mengkaji dan menganalisa data hasil survey atau inspeksi, pencegahan dan perbaikan hasil temuan survey atau inspeksi yang difokuskan pada area yang mempunyai konsekwensi tinggi (High Consequences Area) dan sedang (Medium Consequences Area), serta pelaporan dan evaluasi dari hasil setiap tahapan proses tersebut untuk dilakukan perbaikan yang berkesinambungan.

Gambar 2.6. menjelaskan alur pelaksanaan pipeline integrity managemen system.

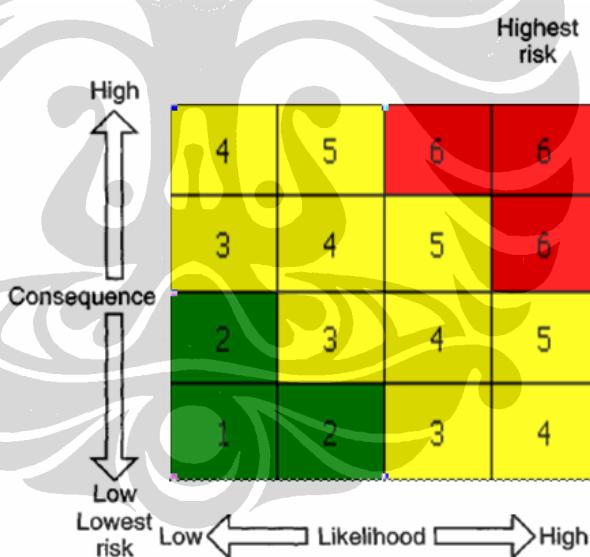
Gambar 2.9. Model Matrik Resiko

Salah satu struktur pengkajian risiko yang paling sederhana adalah analis keputusan dengan suatu acuan/matriks. Ini mengelompokkan resiko pipeline menurut probabilitas dan potensial konsekuensi dari suatu peristiwa pada skala yang sederhana, seperti tinggi, sedang atau rendah atau skala yang kuantitatif; sebagai contoh 1 hingga 5. Masing-masing threat merujuk pada suatu sel dari matriks berdasarkan pada probabilitas dan konsekuensi yang ada. Bahkan dengan keduanya berada pada suatu probabilitas dan konsekuensi yang tinggi maka akan muncul yang lebih tinggi dan akan menghasilkan daftar yang diprioritaskan. Pendekatan ini bisa juga menggunakan judgment expert atau suatu penerapan lebih rumit dan akan menghasilkan informasi kuantitatif untuk mengelompokkan rangking dari resiko. Gambar 2.8 menunjukkan suatu model matriks.

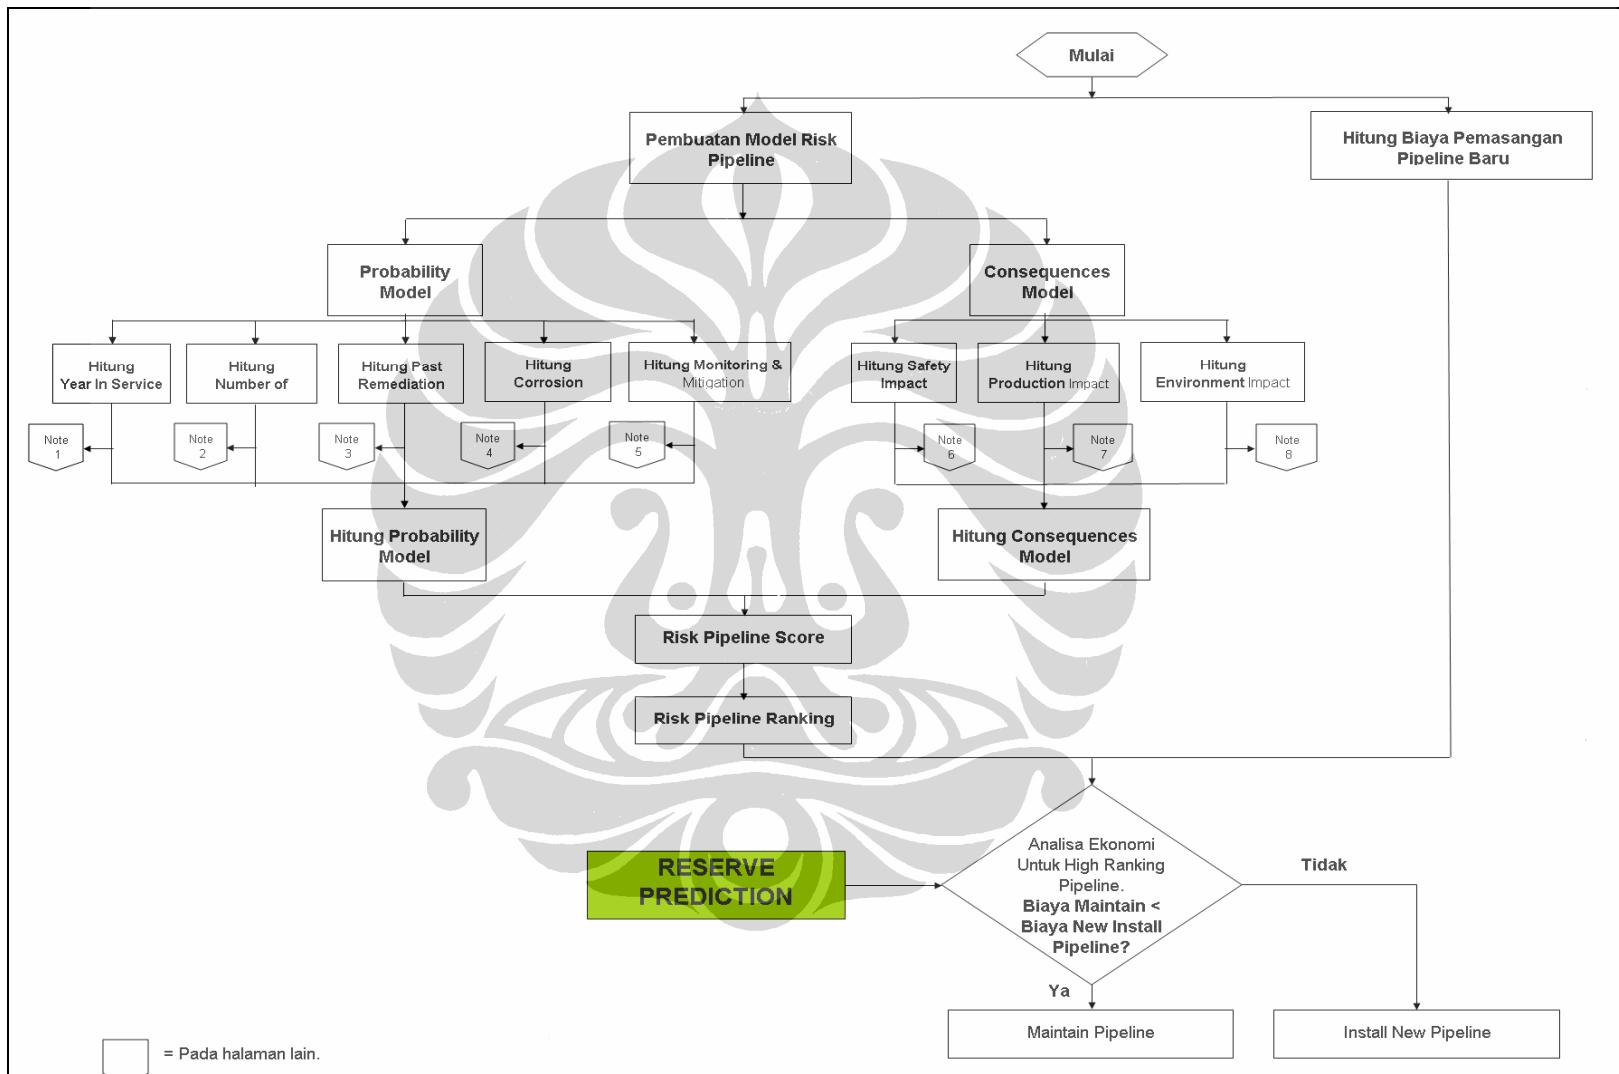
Gambar 3.1. Diagram Alir Metodologi Penelitian

Pada tahap awal penelitian, penulis melakukan pembuatan model risk terhadap pipeline serta melakukan perhitungan biaya memasang pipeline baru. Kemudian dari pembuatan model risk pipeline dilakukan pembuatan model probabilitas dan model konsekuensi. Untuk pembuatan model probabilitas terdiri dari beberapa parameter dan beberapa variabel. Parameter model probabilitas yang digunakan yaitu *year in service* atau umur pipeline, *number of leaks* atau jumlah kebocoran yang pernah dialami oleh pipeline, *past remediation* atau perbaikan yang pernah dilakukan terhadap pipeline tersebut, *corrosion threat, monitoring dan mitigasi* [23]. Sedangkan parameter yang digunakan untuk model konsekuensi antara lain safety, *loss production* dan environment [23].

Dari masing-masing model ini, baik untuk model probabilitas dan model konsekuensi akan dilakukan perhitungan sehingga diketahui *score* atau nilai. Kemudian dengan menggunakan formula 1-1. maka akan dikalikan antara score model probabilitas dengan score model konsekuensi sehingga dapat diketahui score risk pipeline yang dimaksud. Kemudian score tersebut dimasukkan kedalam matriks yang telah ditentukan sehingga dapat diketahui tingkat risk yang terjadi dan termasuk kategori *high, medium* atau *low*. Kemudian dilakukan ranking sehingga diketahui jumlah pipeline yang masuk kategori *high*. Masing-masing score yang digunakan menggunakan beberapa referensi laporan yang ditulis beberapa perusahaan konsultan untuk integrity management.

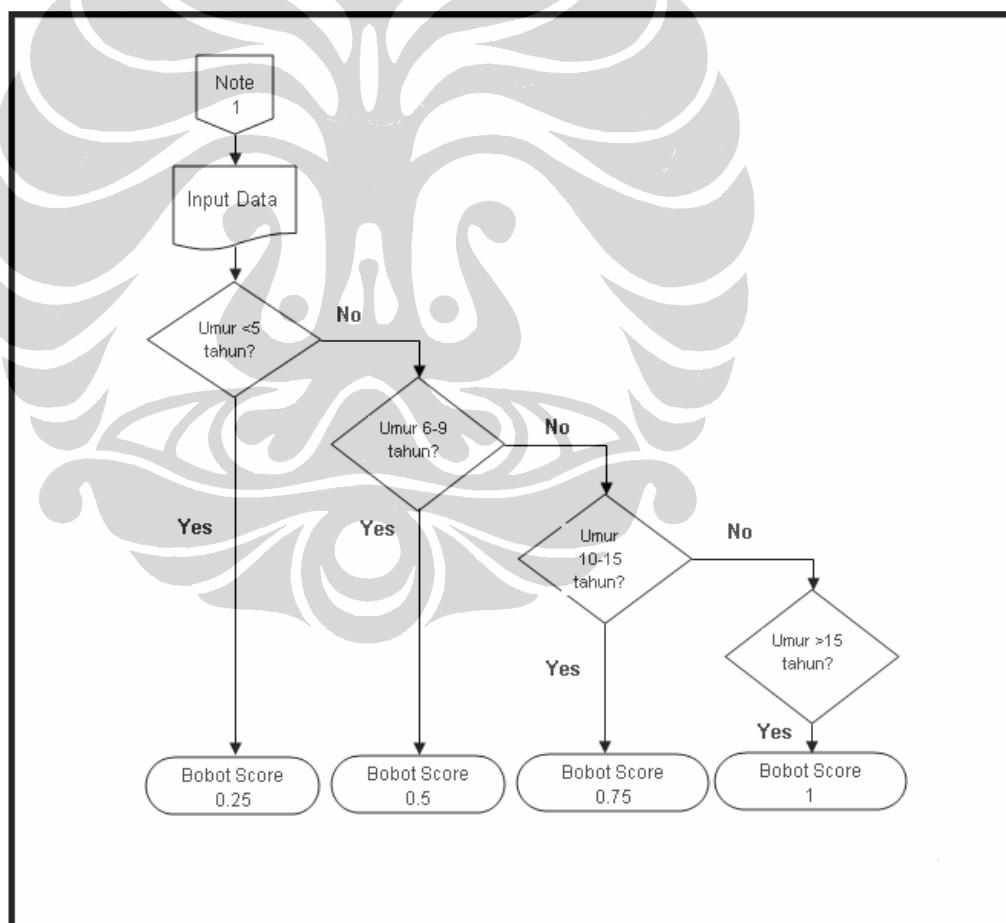
Gambar 3.2. Diagram alir kajian umur pipeline

Bobot Indeks		10%
Umur Pipeline	Score	Bobot Score
< 5 tahun	2.5	0.25
6 - 9 tahun	5	0.5
10 - 15 tahun	7.5	0.75
> 15 tahun	10	1

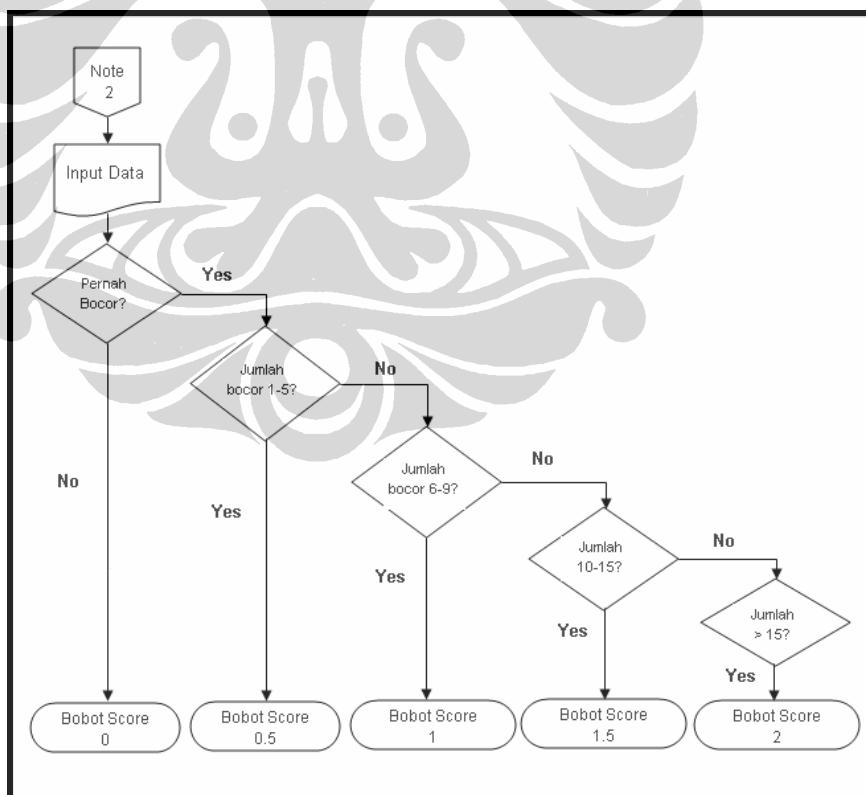
Gambar 3.3. Diagram alir kajian jumlah leaks pipeline

Untuk variabel *number of leaks* atau jumlah leaks, yang dimaksud adalah berapa banyak pipeline tersebut mengalami kegagalan dalam hal ini kebocoran. Variabel ini mempunyai bobot indeks sebesar 20%, dan kategori yaitu tidak pernah leak, jumlah leak 1 hingga 5 kali, 6 hingga 9 kali, 10 hingga 15 kali dan lebih dari 15 kali leak seperti pada Table 3.2. Bobot indeks jumlah leaks. Atau pada Gambar 3.3. Diagram alir kajian jumlah leaks.

Bobot Indeks		20%
Number of Leaks	Score	Bobot Score
0	0	0
1 - 5	2.5	0.5
6 - 9	5	1
10 - 15	7.5	1.5
> 15	10	2

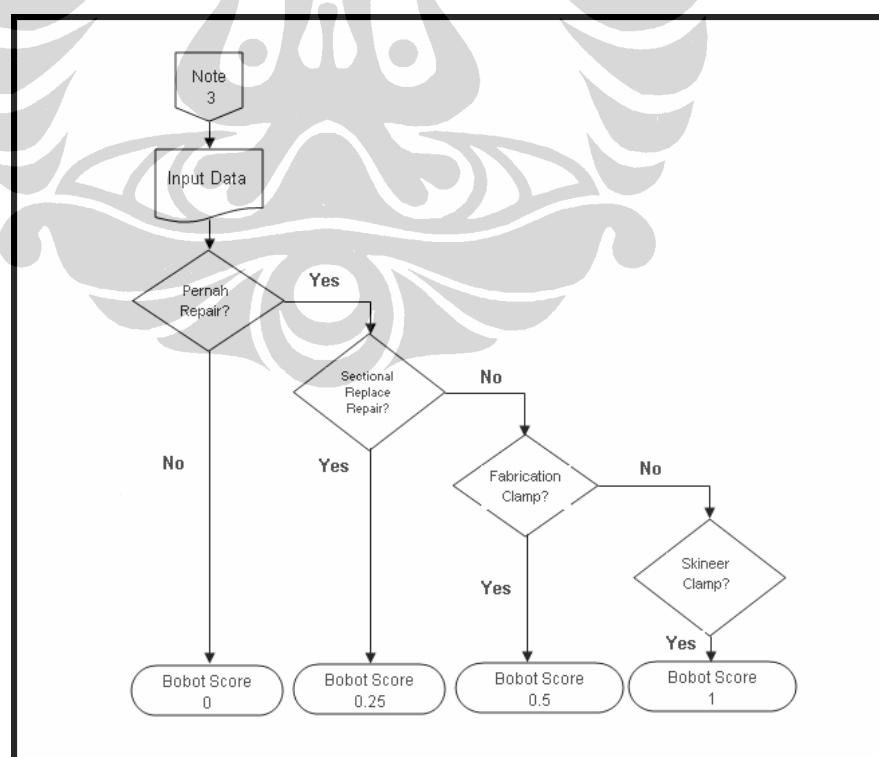
Gambar 3.4. Diagram alir kajian past remediation pipeline

Kemudian untuk variabel *past remediation* atau jenis perbaikan, maksudnya adalah perbaikan yang pernah dilakukan terhadap pipeline dan metoda perbaikan yang digunakan. Variabel ini mempunyai bobot indeks sebesar 10% dengan kategori tidak pernah ada perbaikan dalam hal ini tidak pernah kegagalan, perbaikan sectional replacement, Fabrication Clamp dan Skinner atau Plidco Clamp, pada Tabel 3.3. Bobot indeks jenis perbaikan. Pada gambar 3.4. merupakan diagram alir kajian past remediation dari pipeline.

Bobot Indeks		10%
Past Remediation	Score	Bobot Score
Never	0	0
Sectional Replacement	2.5	0.25
Fabrication Clamp	5	0.5
Skinner Clamp	10	1

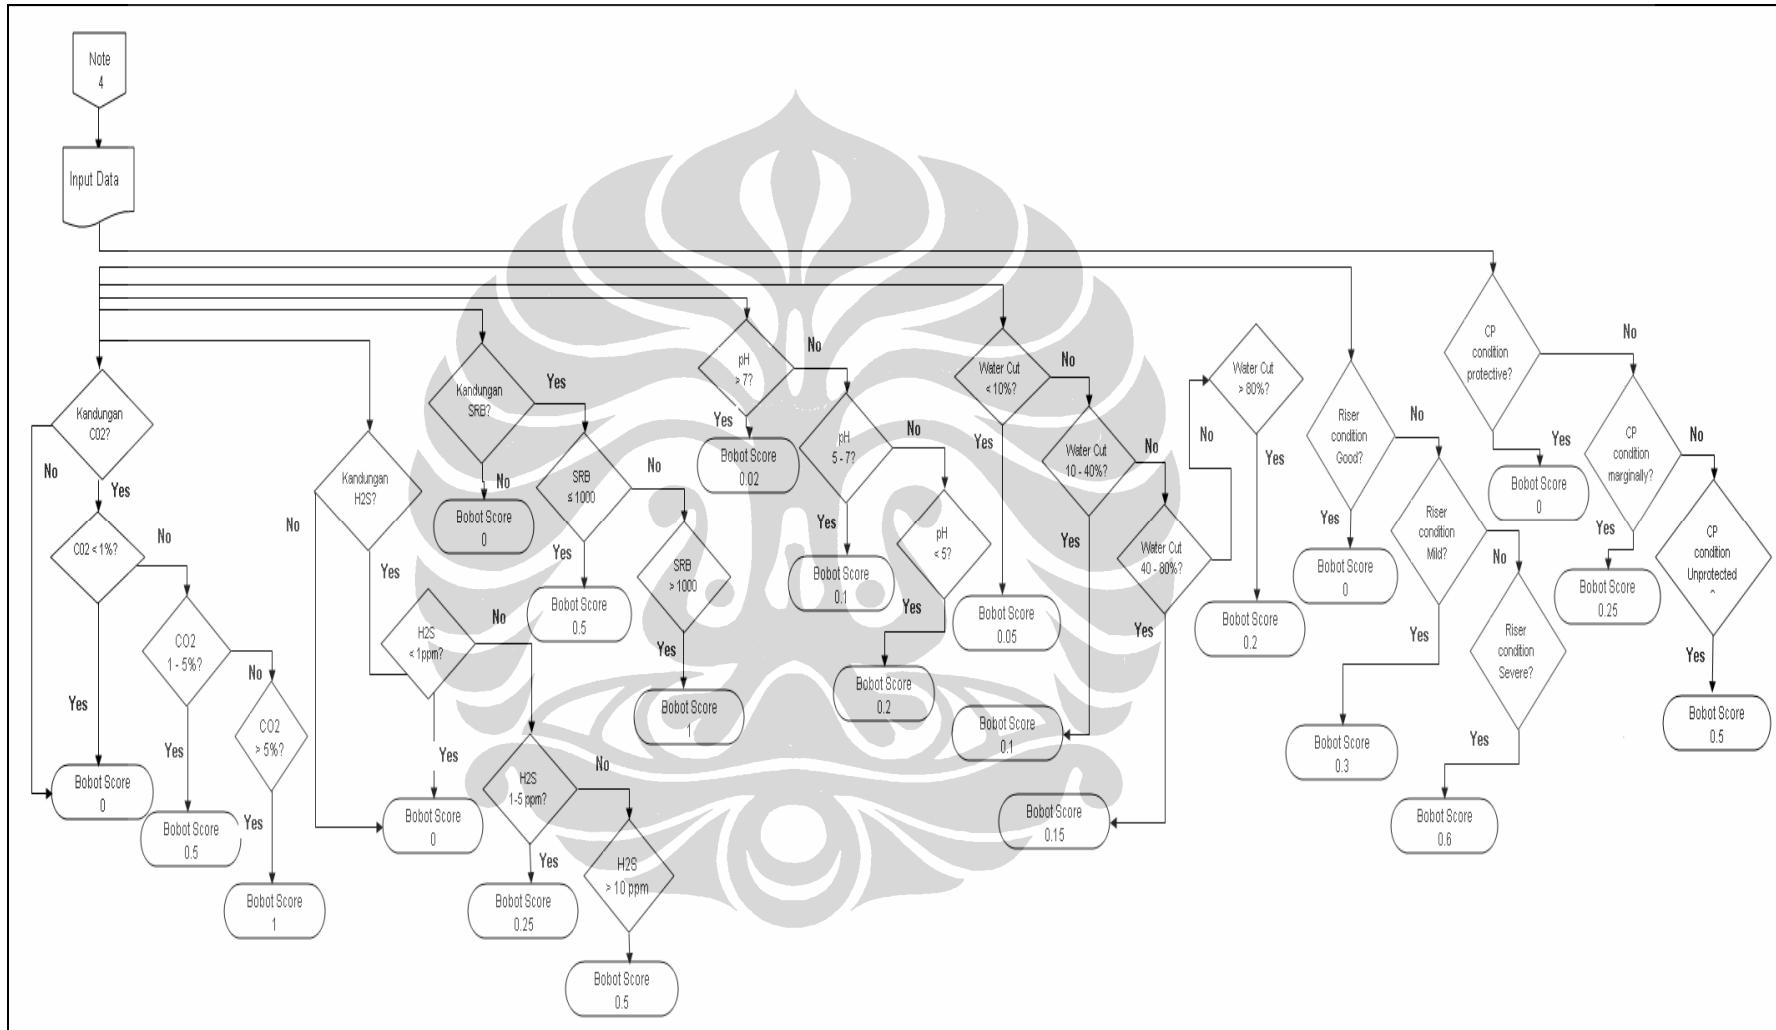
Gambar 3.5. Diagram Alir Kajian Corrosion Threat Pipeline

Untuk variabel *corrosion threat* maksudnya adalah faktor apa yang mempercepat terjadinya korosi di jaringan pipa offshore. Variabel ini mempunyai bobot indeks sebesar 40% dengan kategori internal corrosion terbagi menjadi kandungan CO₂ dengan bobot 10%, kandungan H₂S dengan bobot 5%, kandungan Sulfate Reduction Bacteria (SRB) dengan 10%, pH dengan 2%, kandungan air (water cut) dengan bobot 4%, dan untuk external corrosion terbagi riser kondisi dengan bobot 5%, dan tingkat proteksi katodik dengan bobot 4%. Tabel 3.4. Bobot indeks *corrosion threat* pada pipeline. Pada gambar 3.5. merupakan diagram alir kajian *corrosion threat* pada pipeline.

Bobot Indeks		40%
Corrosion Threat	Score	Bobot Score
CO₂	10%	
< 1%	1	0.1
1 - 5 %	5	0.5
> 5%	10	1
H₂S	5%	
< 1 ppm	1	0.05
1 - 5 ppm	5	0.25
> 5 ppm	10	0.5
SRB	10%	
0 population/ml	1	0.1
≤ 1000 population/ml	5	0.5
> 1000 population/ml	10	1
pH	2%	
> 7	1	0.02
5 - 7	5	0.1
< 5	10	0.2
Water Cut	4%	
<10%	1	0.04
10% - ≤ 80%	5	0.2
> 80%	10	0.4
Riser	5%	
Good	0	0
Mild	5	0.25
Severe	10	0.5
CP Reading	4%	
Protective	0	0
Marginally	5	0.2
Un protected	10	0.4

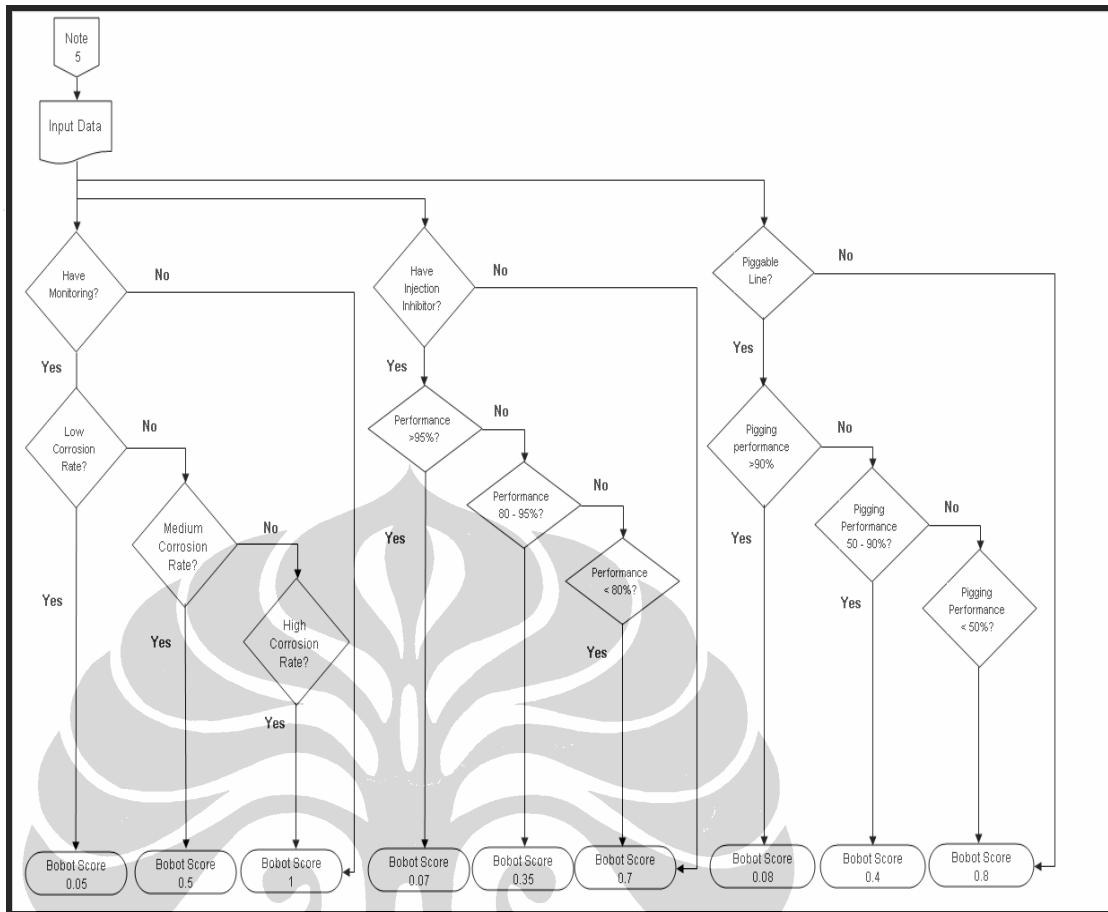
Gambar 3.6. Diagram Alir Kajian Monitoring dan Mitigation Pipeline

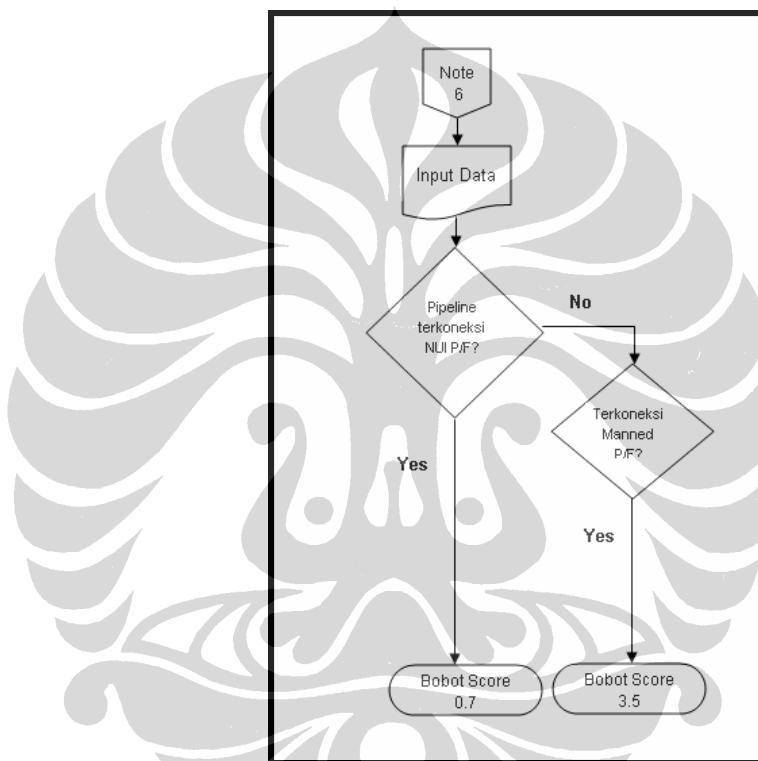
Gambar 3.7. Diagram Alir Kajian Safety Konsekuensi Pipeline.

Variabel safety maksudnya adalah mengetahui tingkat keselamatan jika pipeline tersebut mengalami kegagalan, ini dapat dilihat pipeline tersebut berada di NUI atau station. Untuk variabel ini mempunyai bobot indeks sebesar 35% dengan kategori pipeline berada di manned platform (tempat orang-orang tinggal) atau pipeline berada di NUI platform (tidak ada orang tinggal), karena jika pipeline itu terkoneksi dengan manned platform atau tempat orang tinggal selama bekerja di offshore maka jika terjadi kegagalan pada pipeline maka akan membahayakan para pekerja. Untuk lebih jelas ada pada Tabel 3.6. Bobot indeks kajian safety konsekuensi. Pada gambar 3.7. merupakan diagram alir kajian dampak safety konsekuensi dari pipeline.

Bobot Indeks		35%
Safety	Score	Bobot Score
NUI	2	0.7
Manned	10	3.5

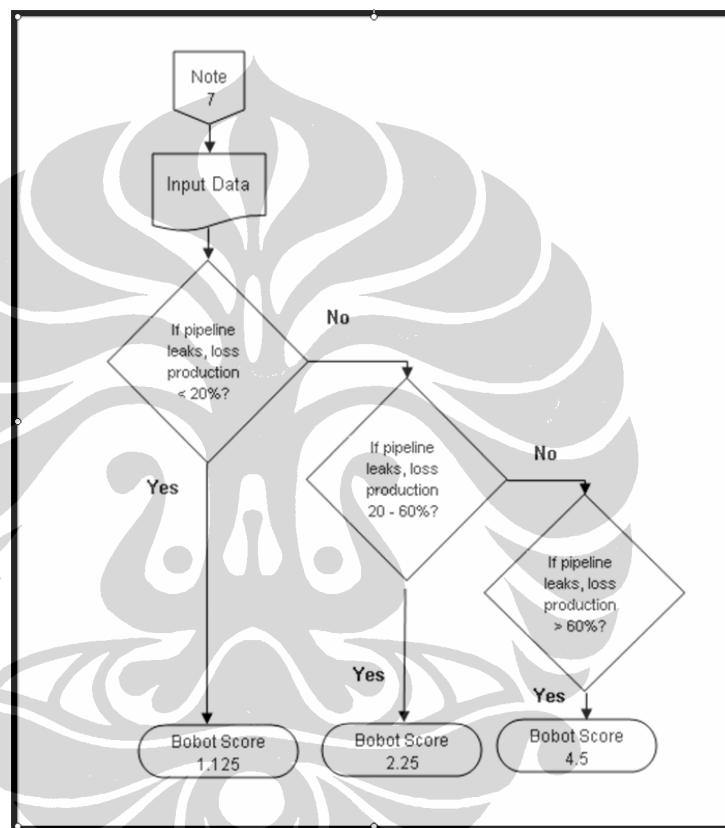
Gambar 3.8. Diagram Alir Kajian Kehilangan Produksi.

Variabel loss production atau kehilangan produksi adalah sejauh mana kontribusi pipeline yang dimaksud terhadap produksi BP West Java secara keseluruhan. Variabel ini mempunyai bobot indeks sebesar 45% dengan kategori kehilangan produksi kurang dari 20%, kehilangan produksi sebesar 20% hingga 50%, dan kehilangan produksi sebesar lebih dari 70%, kehilangan produksi ini konteksnya adalah kehilangan gas produksi dari total produksi gas BP West Java. Untuk lebih jelas ada pada Tabel 3.7. Bobot indeks kajian kehilangan produksi. Pada gambar 3.8. merupakan diagram alir kajian kehilangan produksi.

Bobot Indeks		45%
Loss Production (Total Gas Production BPWJ 260 MMSCFD)	Score	Bobot Score
< 20% Total Prod BPWJ	2.5	1.125
20 - 60% Total Prod BPWJ	5	2.25
> 60% Total Prod BPWJ	10	4.5

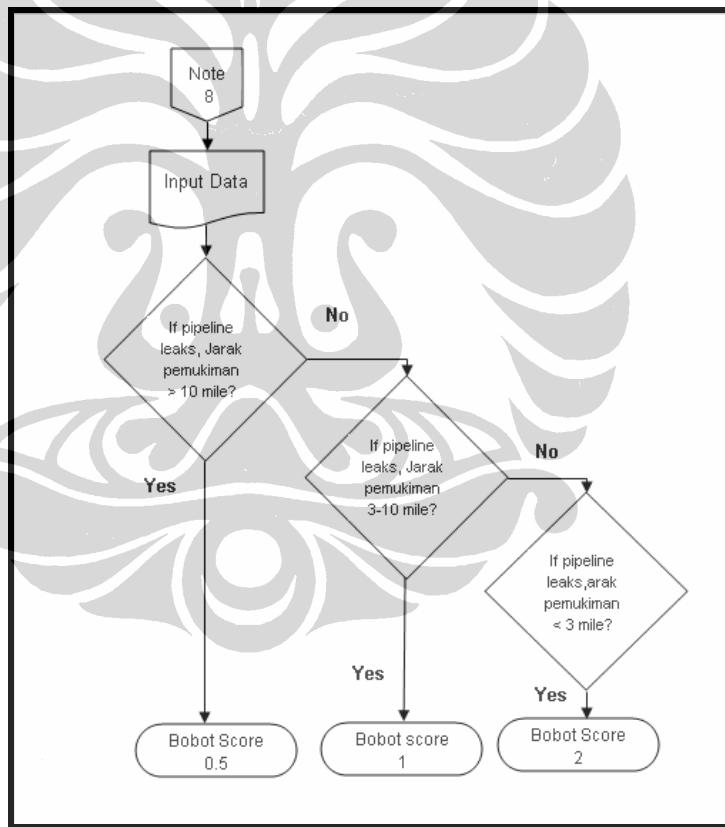
Gambar 3.9. Diagram Alir Kajian Konsekuensi Dampak Terhadap Lingkungan.

Variabel *environment* atau dampak terhadap lingkungan yaitu seberapa tingkat pencemaran atau kerusakan yang ditimbulkan oleh pipeline yang dimaksud jika pipeline ini mengalami kegagalan atau kebocoran. Untuk variabel ini mempunyai bobot indeks sebesar 20% dengan kategori berapa jarak pipeline tersebut terhadap pemukiman penduduk atau penangkaran satwa, terbagi menjadi tiga yaitu jarak pipeline lebih dari 10 mile, jarak pipeline 3 hingga 10 mile, dan jarak pipeline kurang dari 3 mile dari pemukiman. Untuk lebih jelas ada pada

Bobot Indeks		20%
Enviroment	Score	Bobot Score
> 10 Mile	2.5	0.5
3 - 10 mile	5	1
< 3 mile	10	2

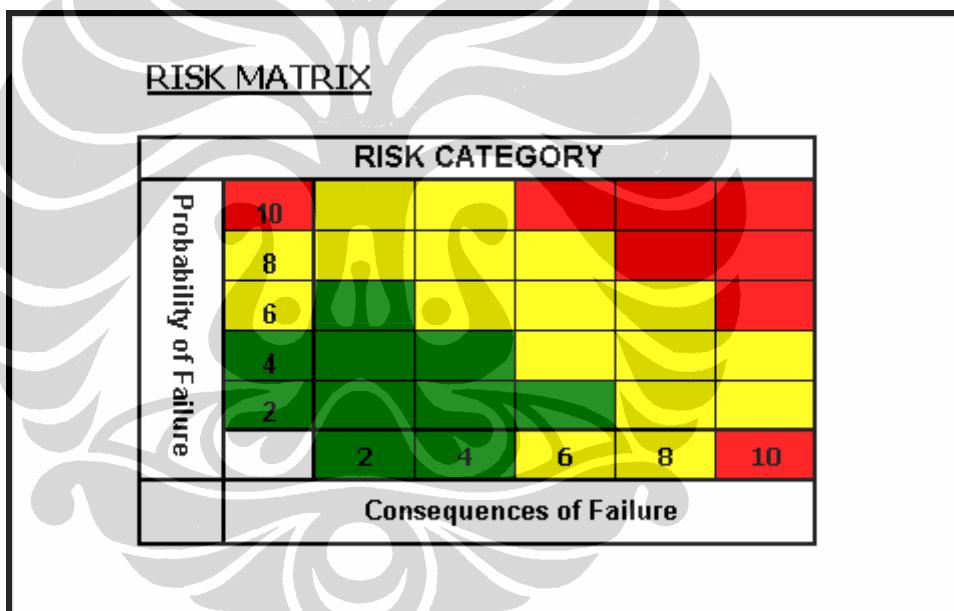
Gambar 3.10. Model Matrik Resiko

Dari total score probabilitas dan konsekuensi tersebut kemudian dikalikan sehingga diketahui nilai resiko pada pipeline tersebut. Kemudian akan dimasukkan ke dalam matriks model yang ada. Matrik yang akan digunakan matrik 5×5 , dengan nilai probabilitas sebesar 1 hingga 10 dan untuk konsekuensi sebesar 1 hingga 10, matrik model yang digunakan seperti pada gambar 3.10 dengan nilai terendah 4 dan nilai tertinggi 100. Dari matriks model ini akan dapat diketahui tingkat resiko dari pipeline tersebut sehingga dapat dilakukan rangking tingkat resiko pada pipeline yang ada.
